Lake Lemon
Aquatic Vegetation Management Plan
2007 Update-Draft
December 10, 2007

Prepared for:
Lake Lemon Conservancy District
7599 North Tunnel Road
Unionville, IN 47486

Prepared by:
Aquatic Control, Inc.
PO Box 100
Seymour, Indiana 47274

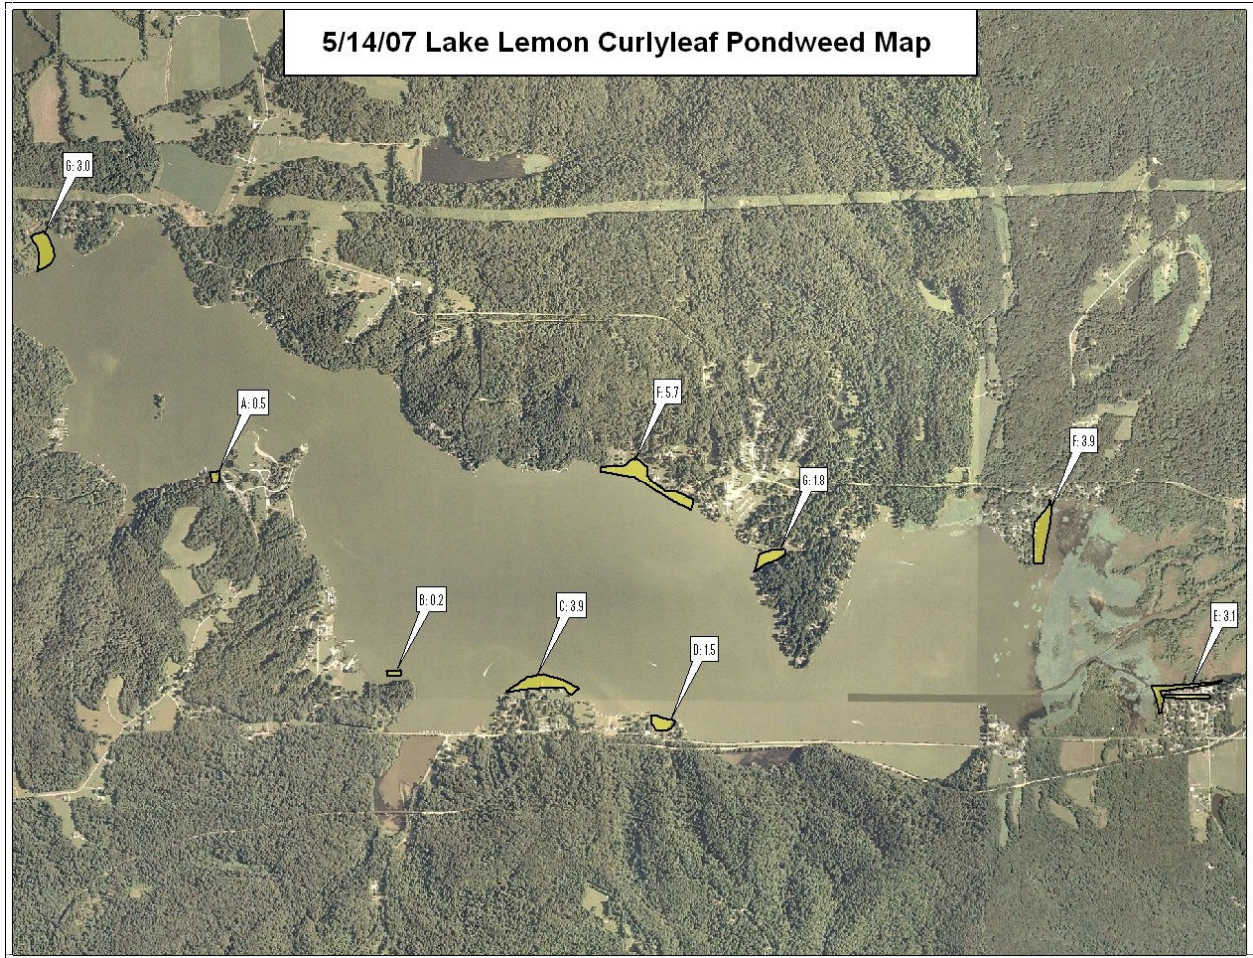
Figure 2. Curlyleaf pondweed beds, Lake Lemon, May 14, 2007

The survey revealed that 144.8 acres of Eurasian watermilfoil (Figure 1) and 23.6 acres of curlyleaf pondweed (Figure 2) existed within the littoral zone. The majority of the Eurasian watermilfoil was found in the upper end of Lake Lemon. Of the 144.8 acres of Eurasian watermilfoil, 96.4 acres is considered to be dense (>50% abundance). Curlyleaf pondweed was considered to be spotty (<50% abundance) at all mapped locations.

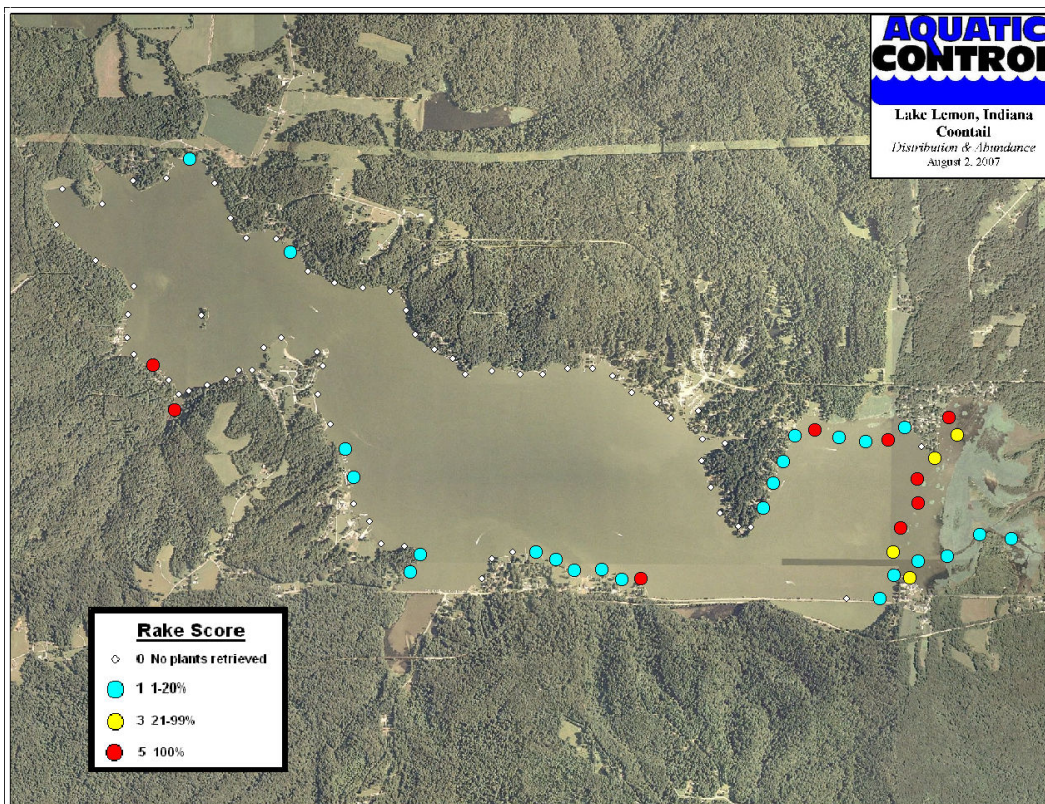
Figure 4. Lake Lemon, coontail distribution and abundance, August 2, 2007.

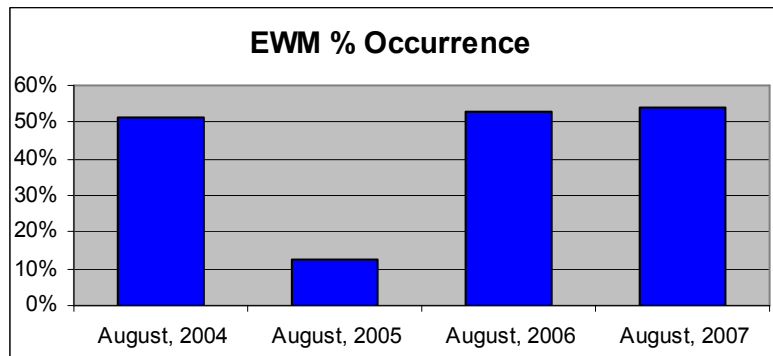
Figure 5. Lake Lemon, comparison of Eurasian watermilfoil percent occurrence in the last four surveys.

One of the primary goals of the vegetation management plan is to reduce the negative impacts caused by Eurasian watermilfoil. Due to a reduction in funding and a lack of LLCD funds in 2007, it was decided that dense, inshore beds of mixed vegetation would be treated with contact herbicides. These treatments would be funded by LLCD. Beds of Eurasian watermilfoil that were allowed to spread outside high use areas in 2006 would be targeted with systemic herbicides funded by LARE. The results indicate that milfoil frequency of occurrence remained about the same as the 2006 August sampling with no significant increase in milfoil abundance (Figure 5). In section 2.2, Figure 3 illustrates the location of milfoil in the summer survey. Areas that contained milfoil were areas that were primarily treated with contact herbicide as opposed to systemic herbicides. The upper end of the lake contained no milfoil. This was likely due to the large systemic treatment that was completed on that area in the spring of 2007 (treatments will be discussed in more detail in section 3.0).

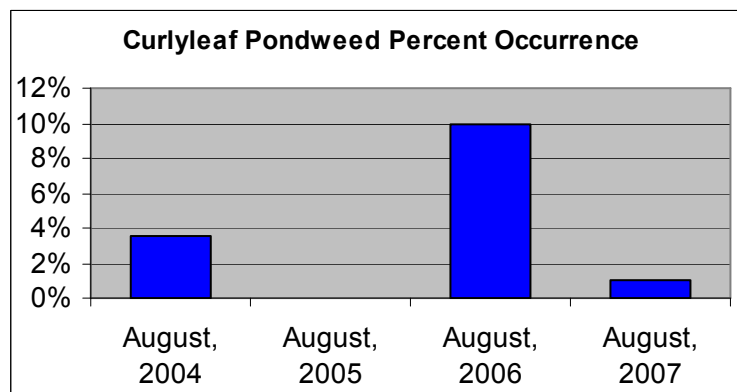
Figure 6. Lake Lemon, comparison of curlyleaf pondweed percent occurrence in the last four surveys.

Curlyleaf pondweed did not reach nuisance levels in the spring of 2007. This species has historically not been a problem in Lake Lemon, but did become a nuisance in the spring of 2006. The invasive species mapping survey completed in May 2007 found curlyleaf pondweed to be rather sparse throughout the lake. A strange phenomenon occurred last year where curlyleaf pondweed did not senesce like it typically does in the summer. This plant was present at 10% of the summer sample sites in the 2006 survey compared to no sites in 2005 (Figure 6). The August 2007 Tier II found that curlyleaf had decreased from 10% to 1.0%.

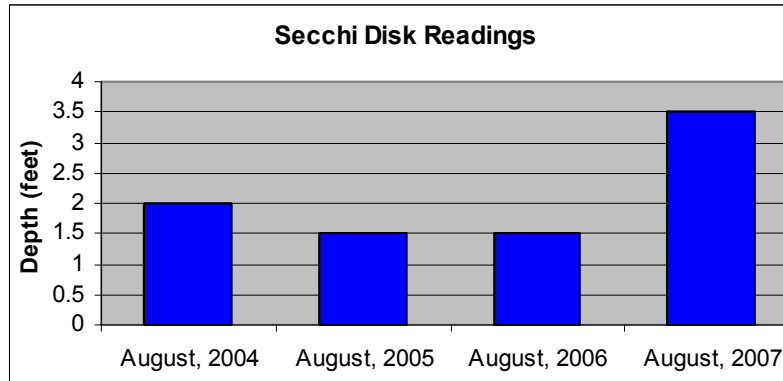
Figure 7. Lake Lemon, comparison of Secchi Disk readings in the last four surveys.

Another goal of the vegetation management plan is to preserve and enhance the native plant community. The main limitation to native plant growth in Lake Lemon is the lack of light penetration caused by dense algae blooms. These blooms typically occur in late July or August. There appears to be a marked improvement in the water clarity. Secchi readings for August 2007 were the highest recorded since Tier II sampling began (Figure 7).

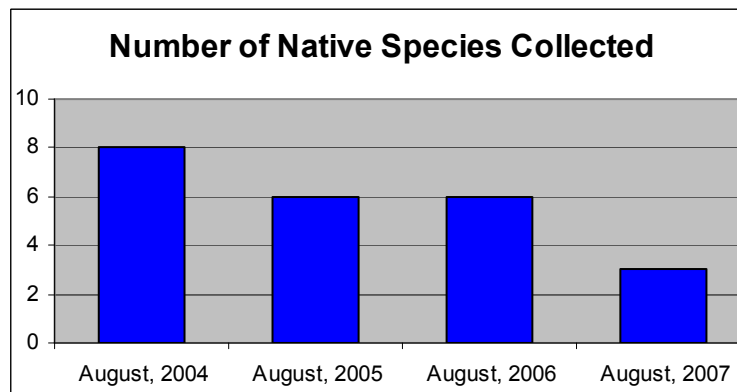
Figure 8. Lake Lemon, comparison of the number of native species collected in the last four surveys.

There was an increase in the use of contact herbicides this season in order to avoid the need to complete multiple treatments to the same areas. This may be the cause of a decrease in the native diversity and a slight decrease in native abundance (Figures 8 & 9). Despite the slight reduction in species diversity and native abundance there was an increase in the number of sites with plants (Figure 10).

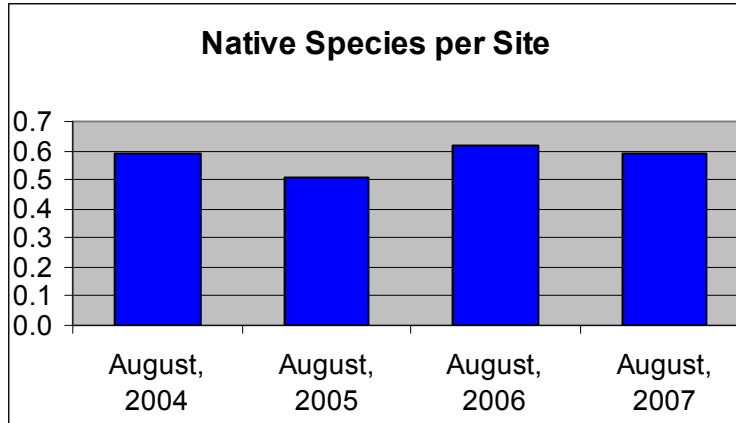
Figure 9. Lake Lemon, comparison of the average number of native species per sample site in the last four surveys.

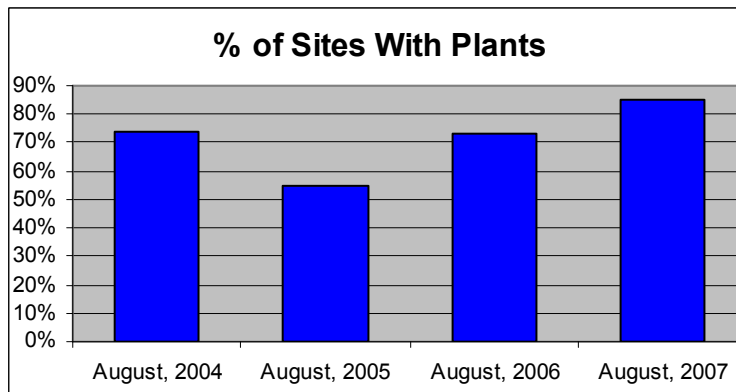
Figure 10. Lake Lemon, comparison of the percentage of sites with plants in the last four surveys.

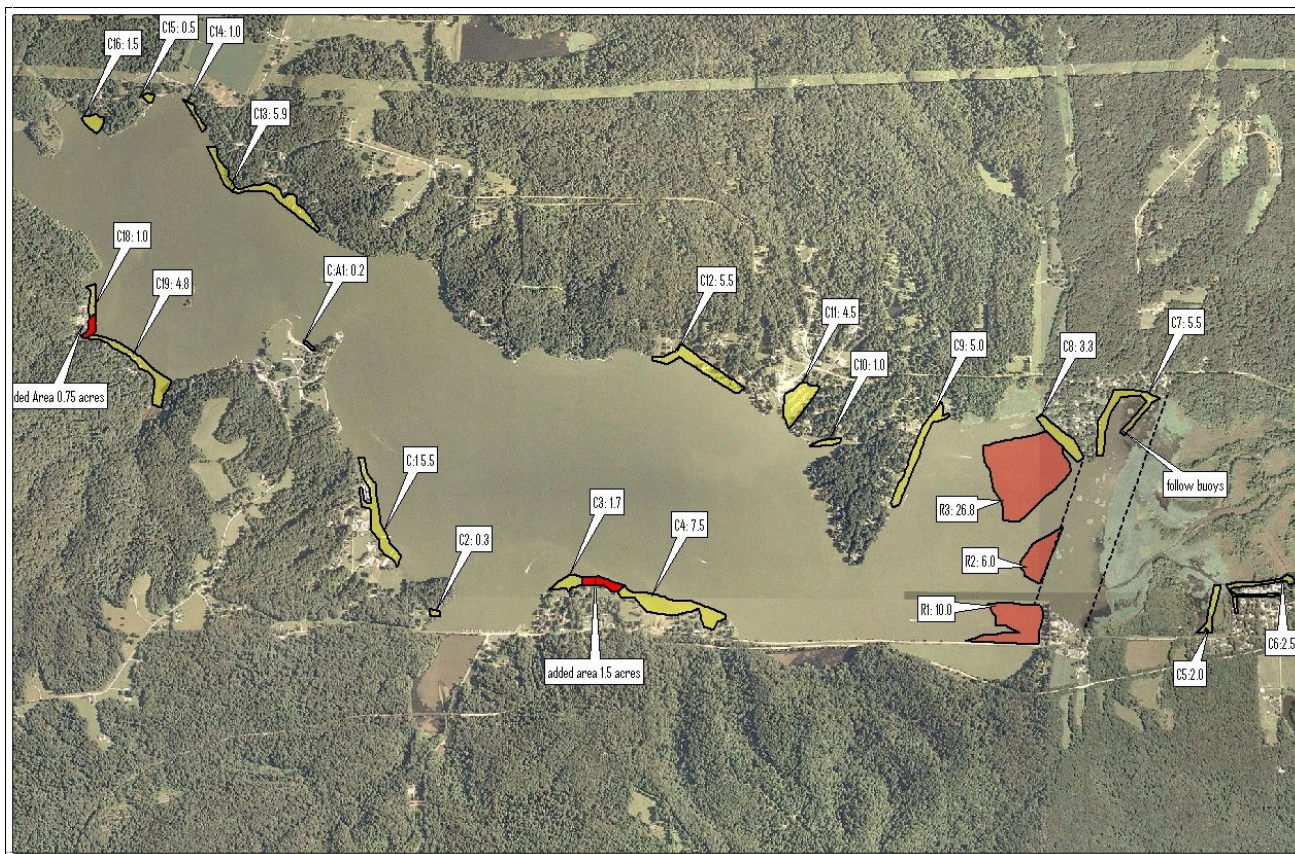
Figure 11. Lake Lemon. Eurasian watermilfoil (red areas in upper end) and submersed vegetation (yellow areas) treatment, May 23, 2007.

In 2007, LLCDD received a \$20,000 grant from LARE for treatment of milfoil with Renovate herbicide. In addition, LARE also awarded a \$4,680 grant for plant sampling and plan updates. The first treatment was completed May 23 to 42.8 acres of Eurasian watermilfoil located in the upper end of Lake Lemon. Renovate 3 (active ingredient: triclopyr) was used in this application at a rate of 1.25 ppm. Product was applied with a 16-ft airboat equipped with a pumping system. Herbicide was delivered through a pair of 3-foot dropper hoses. LARE funds were used for this treatment. On the same day 61.3 acres of submersed vegetation was also treated with contact herbicides. A combination of Aquathol K (active ingredient: endothal) and Komeen (active ingredient: copper) were used in the application. The contact herbicide treatment focused on control of vegetation in near-shore high-use areas. GPS devices were in both applications in order to allow for precision delivery of the proper rates of product to the proper areas (Figure 11).

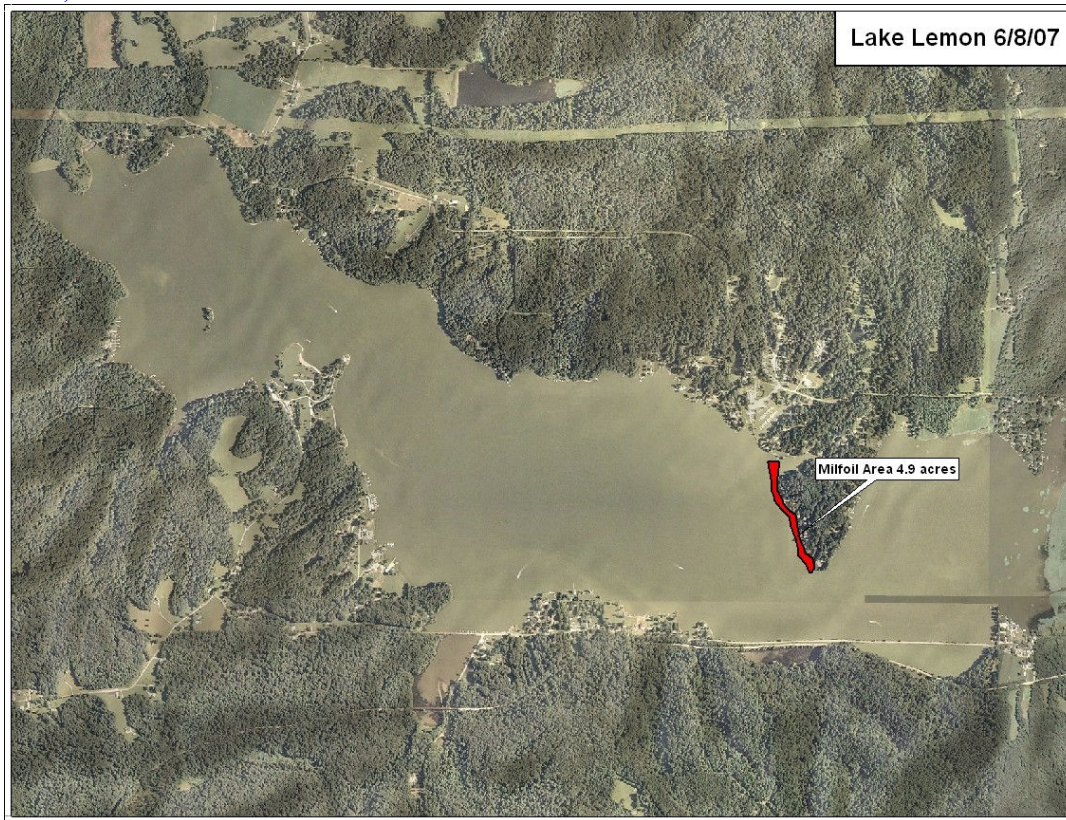
Figure 12. Lake Lemon Eurasian watermilfoil treatment, June 8, 2007.

The second treatment of the season was completed on June 8. Approximately 4.9 acres of Eurasian watermilfoil was treated with Renovate herbicide at a rate of 1.5 ppm (Figure 12). In addition, 15.3 acres of shoreline received treatment with an Aquathol/Komeen combination (Figure 13). Several small shoreline areas that were treated in May were touched up due to an unacceptable level of control (areas highlighted in black on Figure 13).

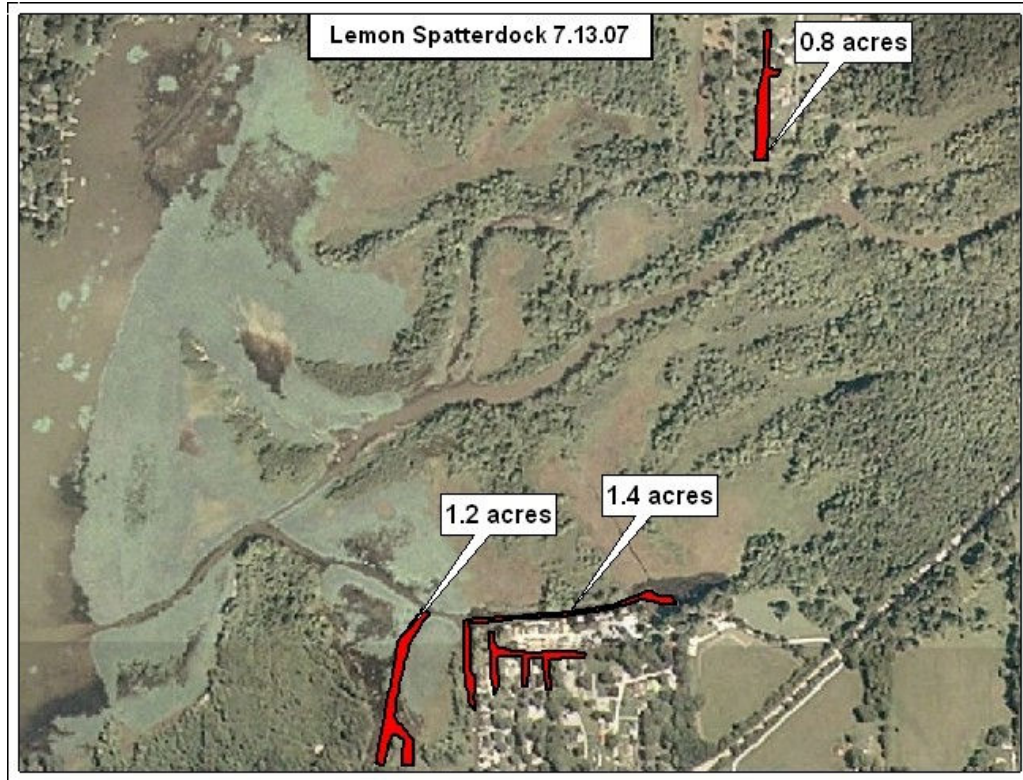
Figure 14. Lake Lemon spatterdock treatment areas, July 13, 2007.

On July 13, 3.4 acres of spatterdock, which was interfering with boating lanes, was treated with Aqua-pro herbicide (active ingredient: glyphosate). These areas were located on the east end of Lake Lemon in an area know as Chitwood (Figure 14). In addition, 0.8 acres of mixed vegetation was treated with Aquathol/Kommen herbicide combination and 0.9 acres of milfoil was treated with Renovate.

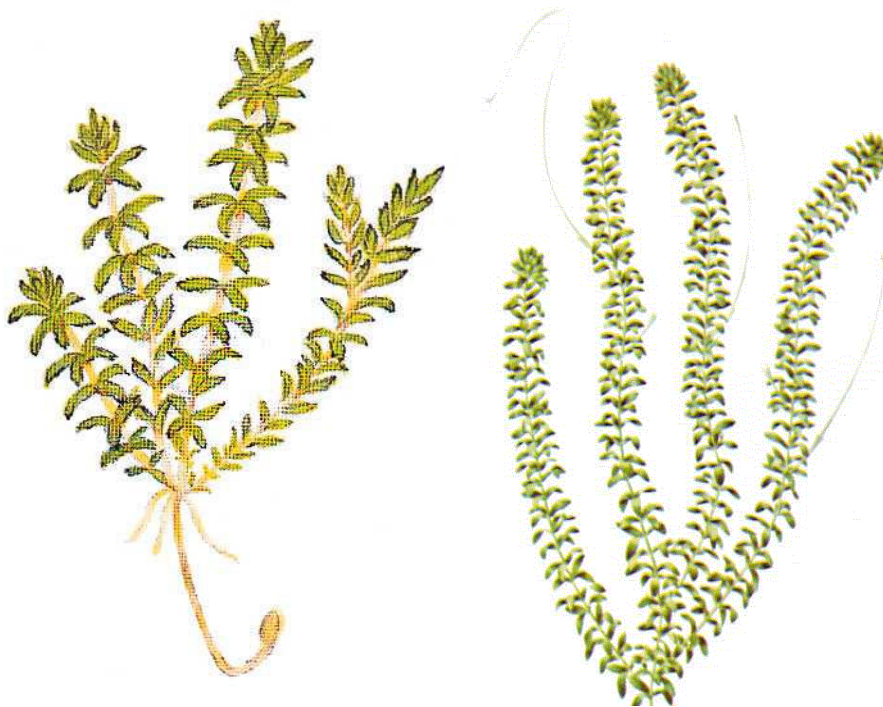
Figure 16. Illustration of Hydrilla on the left compared to native elodea on the right. Hydrilla typically contains five toothed leaves per whorl while native elodea typically has three leaves per whorl and the teeth are not visible on the leaves (Illustrations provided by Applied Biochemist).

Another topic discussed at the public meeting was the discovery of Hydrilla (*Hydrilla verticillata*) in Lake Manitou. Hydrilla is an invasive aquatic species that was originally discovered in Florida in the 1960's. There are many characteristics of hydrilla that make it a threat to Indiana waterways. This species can grow in lower light conditions than most native species, grows faster than most native species, and can shade out other species by forming a surface canopy. Hydrilla can be easily confused with native elodea. The best way to distinguish Hydrilla is that it typically has five leaves along each whorl along with visible serrated edges along the leaf margin (Figure 16). What makes controlling the spread of Hydrilla difficult is the fact that it can be spread by fragments. **That is why it is vitally important that lake users remove all plants and sediment from their boats when entering and leaving Lake Lemon.** More information about controlling the spread of Hydrilla can be found at www.protectyourwaters.net.
